TECHNICAL BULLETIN

EFFECTS ON ASPHALT SHINGLES WHEN ONE ROOF DRAINS ONTO ANOTHER

[June 2019]

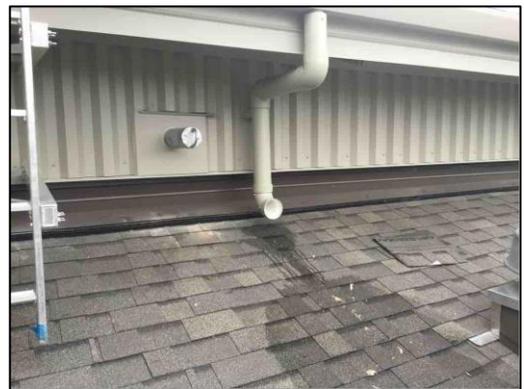
- 4. Granule Loss:** Shingles closest to, or underneath direct drainage, will suffer degradation in another form, the loss of granules. Granules protect shingles from adverse weather and UV rays so losing granules means exposing the underlying asphalt to forces that can increase

weathering, decrease performance, and shorten shingle life. Loss of granules also affects curb appeal as shingles lose their distinctive color.

Installing a splash block under downspouts is recommended, but the optimal solution is to install a trough that runs to the gutter. ARMA advises, “Never allow water from a downspout to discharge directly onto a roof below. Connect an upper story downspout to a lower level gutter with drains installed on the lower roof.”² Examples of this concept are illustrated below but with “drains” being gutters on the lower roof:

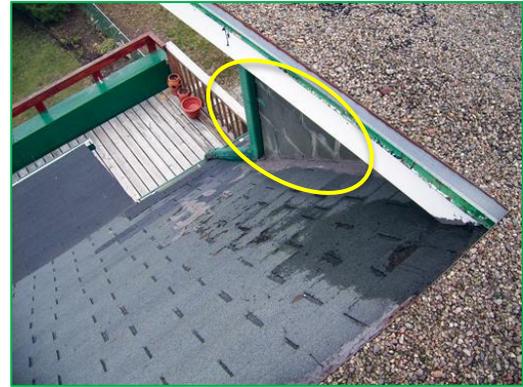
5. **Sidewall Damage:** Sidewalls close to drainage discharge points can be subject to increased moisture as more runoff is channeled their way or splashed when runoff contacts the lower roof. Increased flow will test the installation of flashing at the transition and elements of the wall cladding. Deficiencies will be exposed and can lead to leaks.
