## **TECHNICAL BULLETIN**

### **EFFECTS ON ASPHALT SHINGLES WHEN ONE ROOF DRAINS ONTO ANOTHER**

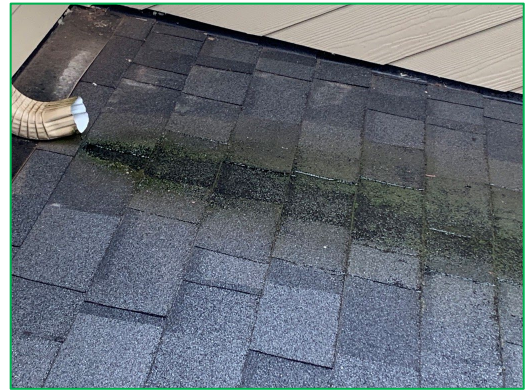
4. **Granule Loss:** Shingles closest to, or underneath direct drainage, will suffer degradation in another form, the loss of granules. Granules protect shingles from adverse weather and UV rays so losing granules means exposing the underlying asphalt to forces that can increase weathering, decrease performance, and shorten shingle life. Loss of granules also affects curb appeal as shingles lose their distinctive color.

Installing a splash block under downspouts is recommended, but the optimal solution is to install a *trough* that channels runoff down to a gutter. The troughs shown below are *open*, but an *enclosed* trough or downspout are also acceptable (see photos next page).

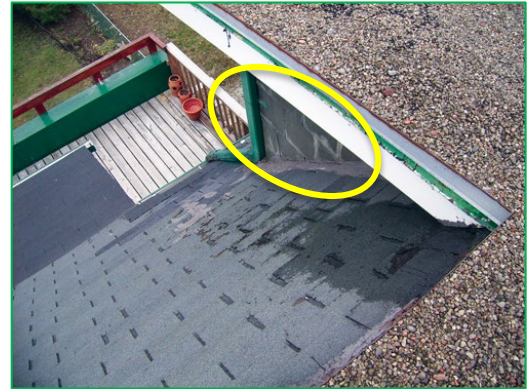
5. **Sidewall Damage:** Sidewalls close to drainage discharge points can be subject to increased moisture as more runoff is channeled their way or splashed when runoff contacts the lower roof. Increased flow will test the installation of flashing at the transition and elements of the wall cladding. Deficiencies will be exposed and can lead to leaks.
