TECHNICAL BULLETIN

EFFECTS ON ASPHALT SHINGLES WHEN ONE ROOF DRAINS ONTO ANOTHER

[April 2024; originally posted June 2019]

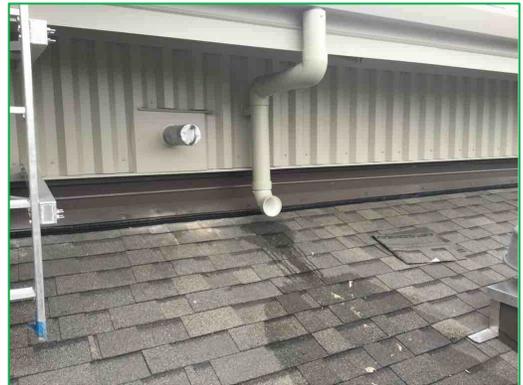
4. **Granule Loss:** Shingles closest to, or underneath direct drainage, will suffer degradation in another form, the loss of granules. Granules protect shingles from adverse weather and UV rays so losing granules means exposing the underlying asphalt to forces that can increase weathering, decrease performance, and shorten shingle life. Loss of granules also affects curb appeal as shingles lose their distinctive color.

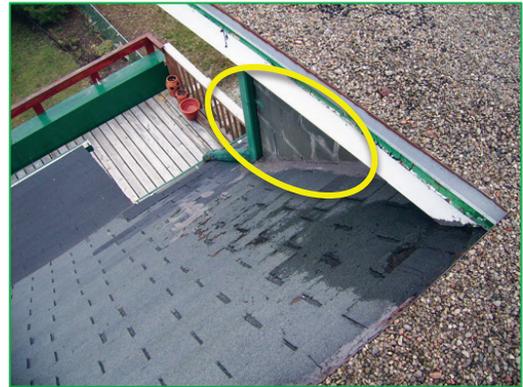
5. **Sidewall Damage:** Sidewalls close to drainage discharge points can be subject to increased moisture as more runoff is channeled their way or splashed when runoff contacts the lower roof. Increased flow will test the installation of flashing at the transition and elements of the wall cladding. Deficiencies will be exposed and can lead to leaks.

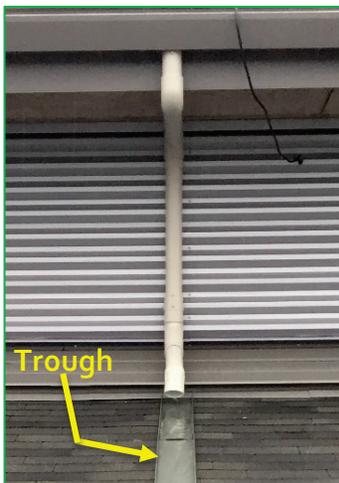
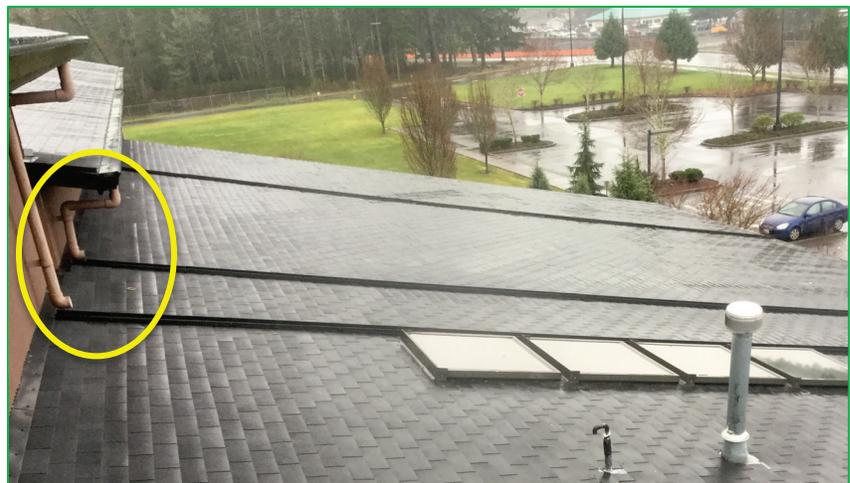
Examples of *Open* Drainage Troughs

Installing a splash block under downspouts is recommended, but the optimal solution is to install a *trough* that channels runoff down to a gutter. The troughs shown below are *open*, but an *enclosed* trough or downspout are also acceptable (see photos next page).

ARMA advises, “Never allow water from a downspout to discharge directly onto a roof below. Connect an upper story downspout to a lower level gutter with drains installed on the lower roof.”² Examples of this concept are illustrated below but with “drains” being troughs on the lower roof.

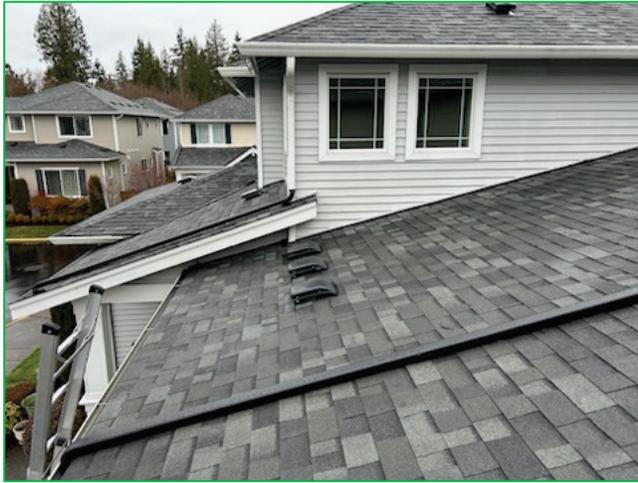
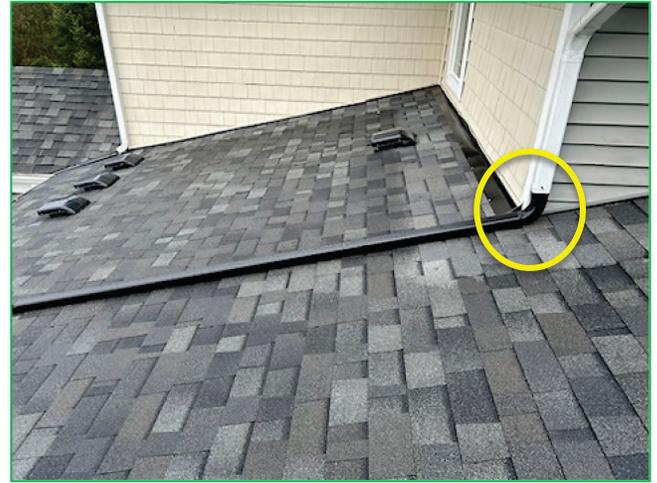
Examples of *Enclosed Drainage Troughs*: Connected to a Downspout (right); and Emptying into a Gutter Below (left)
